## SALVAGE OF SEAKING 525

- Capt SN Ghormade

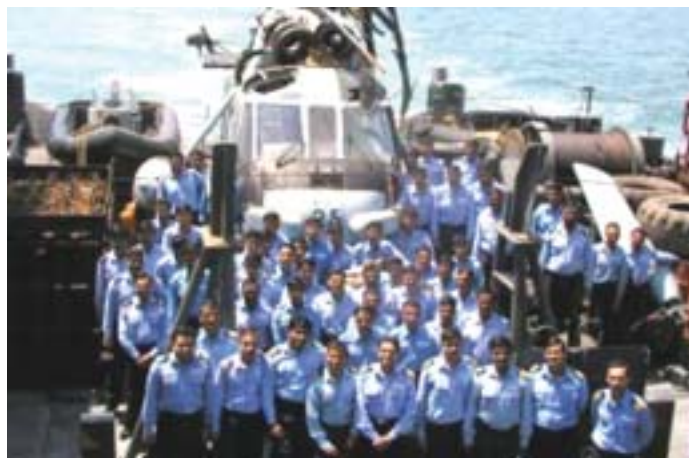
13. The salvage operation was terminated on 07 Apr 03, after a total of 23 h of diving. The ship had successfully achieved the first full-fledged salvage operation of Indian Navy, recovering up to 99 percent of the aircraft from a depth of 70 meters. This was a major achievement for the Indian Navy, as its salvage capability was proved beyond doubt.
